Lessons Learnt from a Significant Event

Issue Number: TLP 007

Title: London Bridge Station Redevelopment, Broken Arm

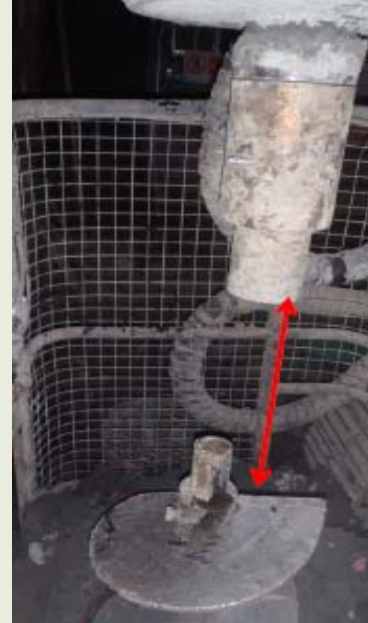
The process involved connecting one auger to the other. Whilst the operative was clearing arisings to reveal the holes in the bottom auger to allow him to insert the bottom pin, the auger slipped from the piling rig head and dropped approximately 200mm. During this motion, the auger flight hit the operatives right arm near his wrist.

The operating process was the main cause of this accident as the top pin was not inserted before the piling operator started to back screw to allow the augers to be attached.

Area showing the distance the auger dropped

- Competent persons should be employed for the tasks they are undertaking, and the safe system of work followed at all times
- Supervisors should satisfy themselves that the operatives are working in compliance with the task briefs and the defined practices for the equipment concerned
- When new risks and controls are introduced, the WPP and Task Brief should also be updated and briefed to the operatives to reflect this.

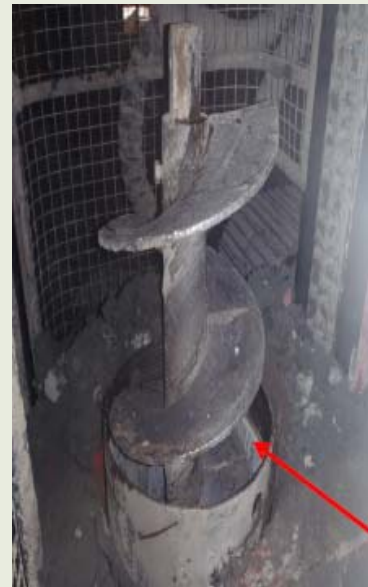
Area showing where the auger caught the operatives arm
