The Thameslink Programme

Issue Number: TLP034

Title: Arch Structure Damage (2nd June 2015)

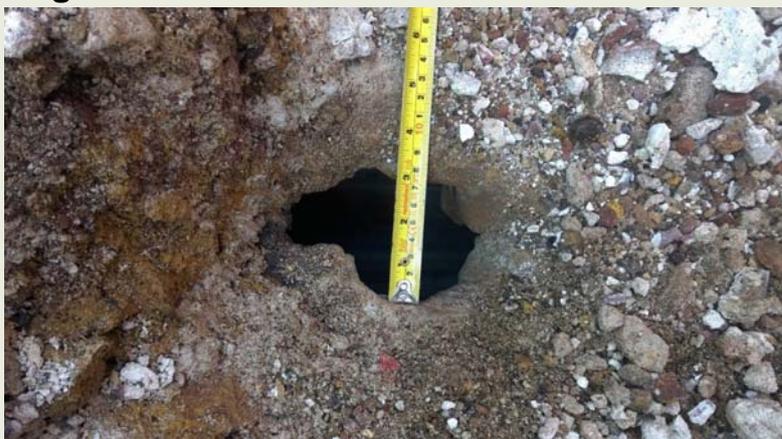
Works to reduce ground levels above the arches at London Bridge station were being undertaken using an excavator mounted breaker (pecker) when the arch below was penetrated and a hole of 100mm x 70mm was created. The arch below was lined with corrugated metal. A small part of a brick fell onto the corrugated metal. The arch below was used as a storage area by a third party.

The arch structure was broken through by the pecker when the operator and banksman, under the direction of the Engineer who incorrectly assessed the position of the arch relative to the datum level they were working to.

Diagram/ Photo of event: Hole created into arch below

- Training on permit and process compliance
- Resource planning strategies (replacement in the event of planned absence)
- Enhancement of the availability of information on underground structures
- Enhanced information on the WPP & TBS on the protocols to be followed when encountering underground obstructions
- Review of competence and selection of suitable personnel to operate excavators where sensitive structures are present
