Shared Learning

COSTAIN
The Thameslink Programme

Issue Number: TLP036
Title: Fire Alarm Activation (24th June 2015)

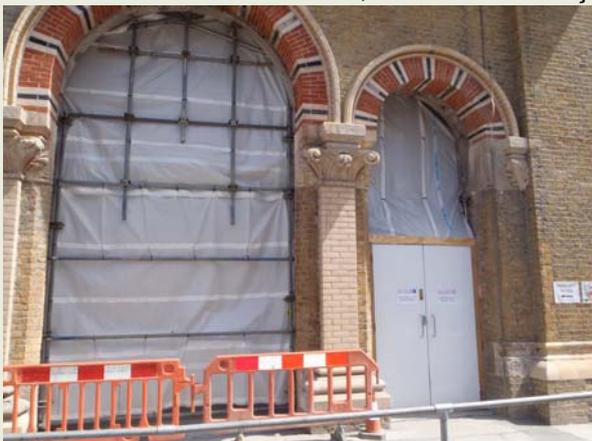
Whilst undertaking waterproofing installation for the St Thomas Street façade shop front (Arch 77) at London Bridge Station the fire alarm system was falsely activated (knocked).

The fixing detail required chemical anchors to be installed which required drilling activity. The drilling created dust-like arisings, which were then blown under a monoflex which was acting as a screen within the arch. The dust was interpreted as smoke and detected by a smoke sensor in a Network Rail operational room. Communications between the station Reception team and the project site team established that a fire was not present; the alarm was 'accepted' and the system reset.

Immediate - The use of a leaf blower to 'clean up' the dust-like arisings was the immediate cause of the incident. This was significant.

- **Hardware:** The ill-fitted Monoflex sheet failed to prevent the passage of dust [under the 150mm gap] through to the operational asset and smoke sensor.

- **Design:** The Monoflex separation detail was not the optimum solution; this left scope for alteration and loss of seal. A more rigid and fixed separation e.g. plywood, would create a better 'seal' preventing ingress of dust and / or debris.

Diagram/ Photo of event: Arch 77, St Thomas St Façade – work place

- Revisions to the WPP and TBS to include more detail on Blue Topper areas and the requirements attached thereto;
- Replacement separation detail between operational and Costain working areas to prevent contamination of the NR asset];
- Improvements to the signing of Blue Topper areas through information boards;
- Briefing sessions to improve and educate engineering teams and operatives of the risks to operational areas from construction activities;
- Development of clearer emergency protocols to enable effective communications in the event of emergency incidents.
