The Thameslink Programme Issue Date: 20 January 2016 For Further Info Contact declan.keane@networkrail.co.uk

Issue Number: TLP 050 Title: Over Head Line Events

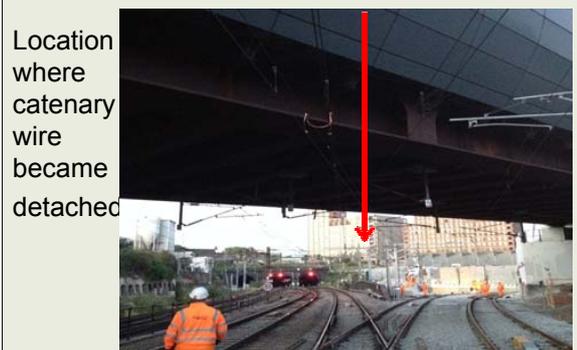
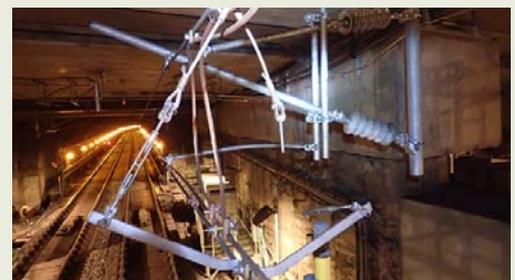
Diagram/ Photo of event:

Overview of Event 1: On 7th of August 2015, it was reported that the catenary wire from the Over Head Line Equipment (OLE) became detached as a train passed beneath the section, between Gasworks tunnel and Copenhagen tunnel, on the East Coast Main Line (ECML). This “dewirement” was identified when the train driver lost her line of sight, witnessing a flash. The train was immediately stopped and a visual inspection took place. During the inspection it was discovered that the catenary wire was draped over the third carriage.

Overview of Event 2: On 4th October 2015, Network Rail OLE Maintenance operatives were undertaking a patrol in the vicinity of St. Pancras Low Level Station when they discovered a detached turnbuckle assembly associated with a Section Insulator (SI) on the Moorgate Line. On further inspection they also identified a detached turnbuckle assembly on the adjacent Section Insulator.

- Issues with how the work was planned meant that works had to be curtailed, and the wire run was left in a temporary state and not to design.
- It was identified through investigation that the follow up works were also poorly planned. It was noted that key personal left post the works and there was no handover or continuity to allow the outstanding works to be planned, which left the wire run in an incomplete state up until the event.
- Inadequate quality control on the design and installation, led to the wrong wire type being installed (catenary not contentary). The wire was left in position rubbing the registration arm which ultimately caused the dewirement.

- Due to resource shortages linesmen were drafted in who had not had previous experience installing OLE equipment on this project.
- Due to wrong positioning of the L-bracket and absence of correct tools, the Section Insulator’s were incorrectly installed
- The turnbuckles did not have locking pins (the manufacturer has since issued new turn buckles with locking pins)

- More efforts have been afforded to robust planning in advance of the final items of work
- A robust interim hand back / maintenance process has been established
- A detailed review of supervision competency has taken place
