**The Thameslink Programme**

**Issue Number: TLP051**

**Title: Tower Crane Dismantling**

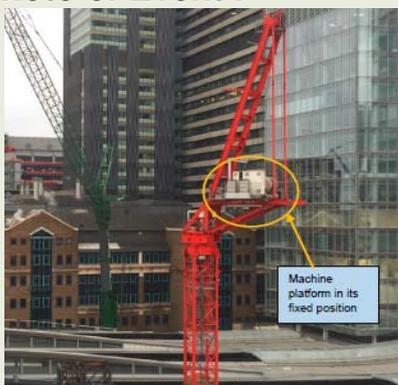
## Photo of Event :

Whilst a mobile crane was being used to dismantle a tower crane (TC2) at London Bridge Station during a possession, a load (hoist drum) became unstable and inverted. As a result of the load 'inverting', objects including two 2.5m scaffold tubes, fell from the load. The scaffold tubes struck the newly installed canopy of Platform 10 and a train carriage berthed at Platform 11. There were no injury to persons. There was a high potential of injury to persons involved in the activity.

The dismantling of TC2 methodology required the mobile crane to 'take the weight' as the locating pins of the hoist drum section to the tower crane were removed. This would allow the load to then be lifted and lowered to the ground. As the final locating pin was removed the load 'sprang', inverted and the load was left suspended on two wire rope slings with the 3rd still attached but not effective (slack rope). A rigging operative directly involved had attached his lanyard to the load prior to removing the pins. As the load inverted he was taken with the load. He remained attached but was able to get himself onto another section.

Incorrect slinging arrangement coupled with incorrect application of lifting force together caused the load to become unstable.

**Procedure:** The manufacturer failed to provide sufficiently clear information in their manual on the variability of the weight of the machine platform relative to the length of rope on the hoist drum. Too much force was applied to the load. A reduced (lift) load would have been adequate to remove the securing pins; this would have allowed the level machine platform to be moved in a more controlled manner toward the centre of slew ring of the tower crane (front of counter-jib) releasing the machine platform from the C-hooks.

**Training :** The Appointed Person (Lifting) did not identify that the weight of the load was different to that stated in the manual – as the manual was for a set amount of rope. The actual amount of rope on the drum was less and therefore the difference in weight affected the centre of gravity of the load. This was not taken into consideration by the AP.

**Communication:** During the installation of a previous tower crane (TC1) it had been identified that an additional shackle was needed to allow the load to lift level. This was never onward communicated for inclusion in lift plans / briefings. Due to this lack of communication the operatives decided (incorrectly) where to introduce the shackle. The slinging arrangement was incorrect: The lifting beam was attached in the wrong configuration. This, in combination with the other vector forces being applied by the lifting operation, contributed to the shifting of the relative centre of gravity.

**Design:** The machine platform and counter-jib do not have proprietary designed anchor points to attach harness lanyards to. The operative attached his lanyard to the wire rope sling on the load. The lack of attachment points was a significant cause in the operative being swept off the crane by the load.

**Design / Procedure:** The illuminated signs on top of the crane were secured to the crane's ballast weights by scaffold tubes. This resulted in loose materials when the signs were removed. The failure to remove or safely secure these items resulted in the damage caused to railway and project assets (train and canopy) when they fell.

- Manufacturer requested to update their manual
- System introduced to make sure the AP takes account of weight where component parts have variances in weight
- Loads to be applied when lifted are to be documented in the methodology paperworks
- Lifting points (lugs) to be identified and marked up for future lifts
- Where additional shackles are required they are to permanently fixed to lifting slings
- All future crane installations are to have permanent / fixed signage
- Anchor points are to be identified with high visibility paint or similar and erection / dismantling work gangs are to be briefed on the clipping on system
