The Thameslink Programme

Issue Date: 7th July 2016 - For further info contact sharon.fink@networkrail.co.uk

Issue Number: TLP060 Title: Pallet Truck Accident

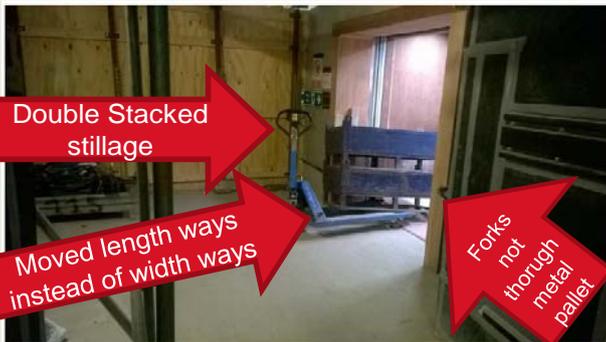
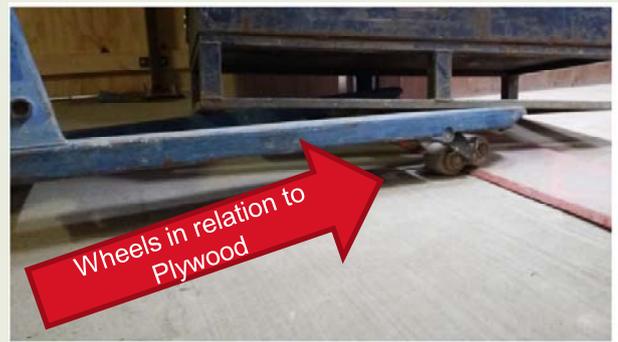
Photo of Event :

A load became unstable during an operation to move counterbalance weights from one area of the site to another on a pedestrian operated pallet truck. An operative sustained bruising to the chest when he was struck by the stillage and was taken to hospital as a precaution. The pallet truck was being used to take 2No. steel stillage's containing 2 x 50 x 20kg weights (total weight approximately 2200kgs including stillage's). The 2No. steel stillage's were stacked on top of each other and rested on top of the steel pallet truck forks. As the pallet truck entered the goods lift the tandem wheels jolted due to the raised plywood protective lip, the jolt caused the stillage's to move sideways and consequently struck the operative before they stabilised. The weights were being moved by operatives into the freight lift and taken to their location as the original planned point for loading with a telehandler was not available. The original team who should have moved these (another contractor) was engaged in unloading another delivery relating to the works.

Immediate Cause – The stillages were double stacked on the top of the pallet truck forks as well as length ways instead of width ways, and this unstable transport position caused the load to tip on the pallet forks and shift position when the tandem wheels were jolted on the plywood lip between the service lift and adjacent concrete floor.

Error-proofing conditions: Incorrect selection of equipment: the pallet truck used had a fork configuration that did not allow the forks to be inserted into the slots of the stillage. This resulted in the forks being put directly *under* the stillage [not captivated] and thus relying on friction to retain the load on the pallet truck forks.

Communication: Failure to adequately communicate the importance of transporting the stillage's individually as opposed to double stacked which increased the instability of the load due to a higher centre of gravity with double stacked stillage's.

- Task Briefing Sheets relating to movement of stillages was amended to include need to forks to be inserted into pallets
- Brief to all teams about the implications of changing the WPP when areas/landing decks are not ready for use and the need to assess and undertake / document a Point of Work risk assessment by the relevant section engineer & the responsible Supervisor/s.
- Brief to all teams that if tasks are allocated to other work teams from other companies the responsible Supervisor needs to complete the Task Briefing on the activity and brief this to the operatives before work commences.
- A review of the Point of Work Risk Assessment process has been undertaken to identify a suitable suite of measures that will enhance the implementation of the PoWRA at site level.
