Balfour Beatty
Rail

The Thameslink Programme

Issue Date: 24th August 2016 For further info contact mike.netherton@networkrail.co.uk

Issue Number: TLP 062 Title: Signal Post Dropped During Lifting Operation

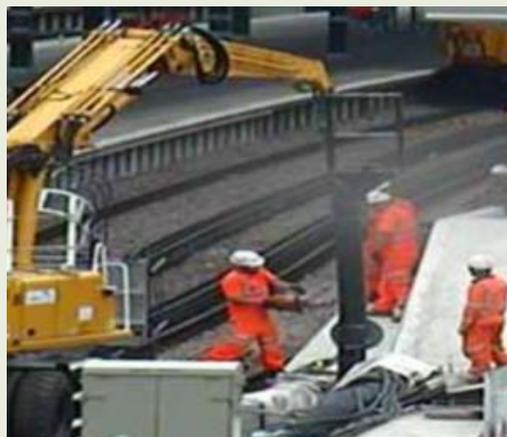
- The signal post fell due to the method of stroping and not being supported vertically whilst being cut

Cutting Post

- A review of the design integration and survey process when planning work
- Future civil's work to be surveyed, and to include the removal of other temporary works for visibility if required
- Detail within in Task Briefing Sheets and Lifting Plans to be examined and improved
- Competence of supervisory staff too be improved through standard training
- Exclusion zones for similar works to be demarcated with barriers
- All Crane Controllers to be reviewed for length of experience and competence in advance of putting to work

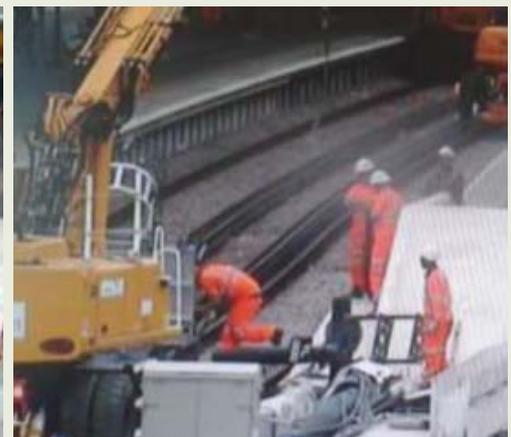
To achieve this, the post was slung using a strop connected to the jib hook of an RRV and the team used a Stihl disc saw to cut the post. As the final part of the post was cut, under tension, it swung towards the RRV and one end of the sling came out releasing the signal post mid-air and it fell to the ground.

The exclusion zone for the lifting activity was inadequate. There were no injuries sustained from the fall and the team then re-stopped the post and lifted it onto a trailer without reassessing the equipment for any damage.

Escaping from falling post
