COSTAIN
The Thameslink Programme

Issue Date: 13th March 2017 - For further info contact sharon.fink@networkrail.co.uk
Issue Number: TLP071 Title: Plant – Person Interface

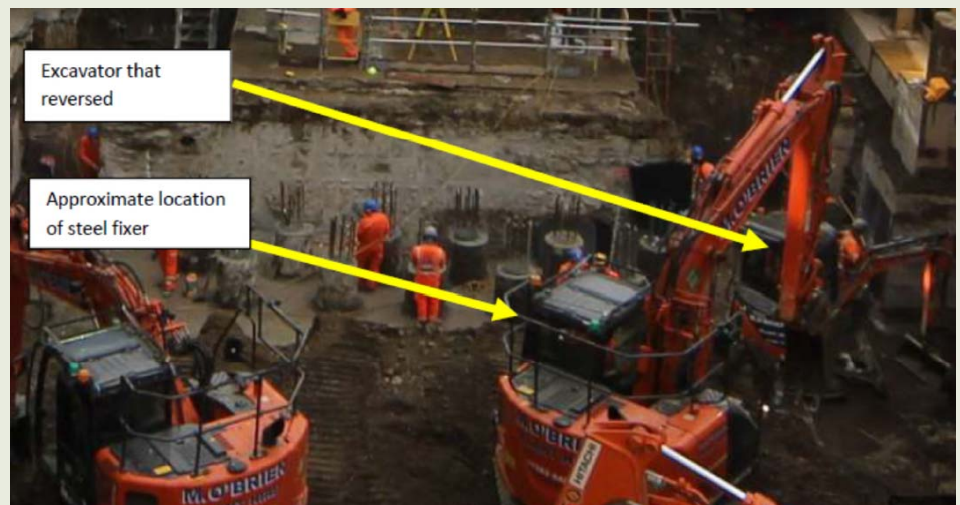
Photo of Event :

A close call was raised when an observer saw a steel fixer working at the back of an excavator with no managed exclusion zone in place. The operative became aware of the movement of the excavator and quickly removed himself from the area. The excavator was under the control and guidance of a banksman at all times and the movement of the machine was a part of the planned activity to scrape material from the area to expose the pile caps.

Immediate Cause – The excavator moved approximately 500mm to within 2.5metres of the steelfixer.

- There were no fixed barriers in place to segregate plant and operative interfaces to ensure minimum distances between mobile plant and operatives was maintained to prevent the steel fixing operative from being in a position of danger. Note: the use of fixed Exclusion Zone barriers was considered problematic at the planning stage and it was concluded that these were not a reasonably practicable methodology.

- The banksman, though correctly positioned, was aware of the steelfixer operative but through a lack of judgement failed to remove the steel fixer from a position of risk. The Banksman stated he only allowed the excavator to move 500mm so the excavator would not contact the steel fixer who was 2.5 metres away after the manoeuvre.

- Due to the perceived limited and confined access one operative was deployed to act as banksman. This was incorrect 2 operatives should have been deployed.

- All Frontline Supervisors, Banksman and Plant Operators were briefed on this particular event and the need for Exclusion Zones to be implemented to manage segregation of plant and people.
- Technology based control system such as the Deadman's switch and Athena communication headsets will be reviewed and suitable systems introduced to improve plant management.
- A point of work risk assessment will be required for all excavator operations that present a risk of workers entering the radius of the machine.
- The management of exclusion zones is under review to establish additional measures that could be implemented to improve this.
