Shared Learning

The Thameslink Programme

Issue Number: TLP075

Title: Spanner Fell from Scaffold

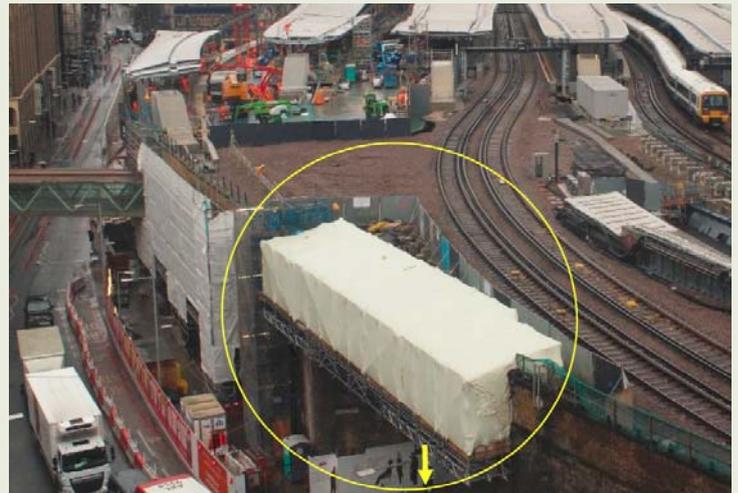
Encapsulated scaffold where spanner fell from

Immediate Cause: A spanner fell through a scaffold that did not have adequate protection to prevent falling objects.

- Design: Scaffolding was designed to carry out grit blasting & painting and not for repairs & strengthening works. This resulted in modifications [removal of plywood infills] that created the 'fall path'. The infills were not adequately detailed in the design drawing and when they were removed they were not properly refitted due to the design [foam seal broken].

- Design / Procedure: Failure by the Temporary Works Co-ordinator (TWC) and others, to identify that the scaffold had not been built in compliance with the design. The shrink wrap (Envirowrap) was not installed to the underside of the scaffold structure rendering the area below unprotected from falling objects once the plywood infills were removed.

- Procedure: The omission of a debris netting system to mitigate the risk of falling objects, and in particular where the plywood seals were removed, resulted in the loss of a barrier to the risk, namely inadequate falling object protection.

- All scaffold over public areas reviewed for netting / encapsulation.
- Process being developed for scaffold / changes to scaffolding to take account of lessons learnt from previous events.
- Engineers have undergone risk management training.
- Engineers have undergone an engagement session with regards to their safety responsibilities.
- WPP revised.
- WPP process rebriefed to the team including compliance to the process. This will also be reviewed at weekly WPP review meeting.
