The Thameslink Programme

Issue Date: 12th June 2017 - For further info contact sharon.fink@networkrail.co.uk

Issue Number: TLP076 Title: Arch Penetration

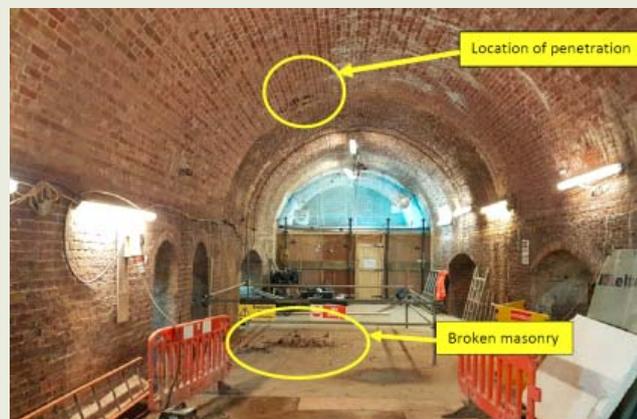
At approximately 0100 hours on Saturday 1st April, the shoulder of an arch on the London Bridge Station Redevelopment Project was breached when excavating overburden for the formation of a pin for a structural ground beam. Approximately 5kg of fragmented masonry fell into the gallery area below. There were no injuries and no persons in the immediate vicinity. The incident was initially classed as a close call however, on reflection the project team have now decided that this should be treated as significant due to the potential to undermine the structure.

Photo of Event : Arch that was penetrated

Immediate Cause – The unplanned breach off Arch 1008 by the action of the machine mounted breaker.

- Design/Procedure: The information on the Permit to Dig stated arch levels that were inconsistent with the actual levels of Arch 1008, it therefore lacked adequate detail to identify the various pin positions relative to the Arch (arched) profile.

- Engagement session held with Engineer about his role and process.
- Engineers and Supervisors have been reminded of their safety responsibilities.
- Weekly audits will review the accuracy of engineering detail in the Permit to Dig with a dedicated resource allocated.
- Permit to demolish has been rebriefed to the team.
