The Thameslink Programme

Issue Date: 12th June 2017 - For further info contact sharon.fink@networkrail.co.uk

Issue Number: TLP077 Title: Debris Fell into Public Area

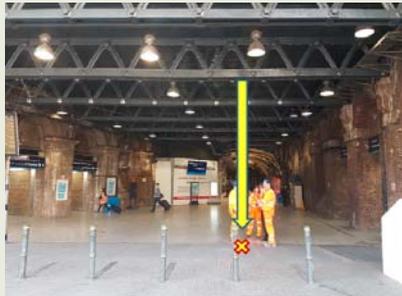
Location where debris fell

Immediate Cause – Concrete debris fell through an uncharted downpipe into the public realm.

- CREs briefed to communicate reason for requests for surveying to contextualise it. This will allow surveyors to better understand the potential risks. Survey manager briefed to brief the survey team as this requirement.
- Senior Manager 1-2-1s are being accelerated and particular attention paid to this area.
- Project Director and Construction Manager met to review programme and safety commitments.
- All Engineers and supervisors have received a briefing reminding them of their safety responsibilities.
- The Engineers concerned and the wider engineering community were engaged with a 'follow the process' message.
- WPP sign off process reviewed for re-sign off requirements when changes occur.

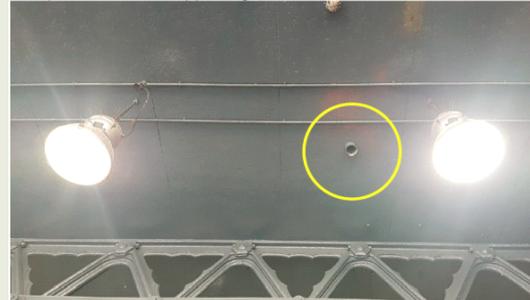
View up to Joiner St. Note downpipe through which the debris fell

- Design/Procedure: Information on the Permit to Dig and drawings did not identify the downpipe through the soffit.
- Procedure: Supervisor and Engineer did not reassess the work when they were instructed by the Construction Manager (CM) to reschedule the from nightshift to dayshift. The CM believed that the Engineer and Supervisor would undertake a detailed risk assessment, including the Point of Work Risk Assessment [PoWRA]. He failed to check that the specific risks relating to undertaking the work on dayshift had been adequately identified and mitigated.
