Shared Learning

The Thameslink Programme

Issue Date: 26th October 2017 - For further info contact mike.netherton@networkrail.co.uk

Issue Number: TLP081 Title: Mobile Tower Pole Came In Contact with an Energised Conductor Rail

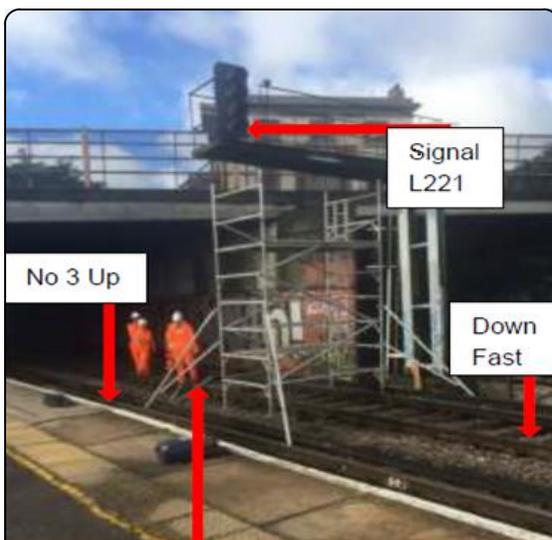
As the possession moved into Part 2, operatives were dismantling the scaffolding, after carrying out a survey, when a scaffold pole was dropped and came to rest between the No 3 Up Line conductor rail and the Down Fast running rail, causing a flashover.

Immediate – Work party were unaware an isolation had been lifted on an adjacent line and a metallic scaffold pole came into contact with a conductor and running rail causing a flashover.

- Two COSS's failed to come to a clear understanding of the work site limits and isolated lines between Part 1 and Part 2 of the possession . Furthermore, although briefed, they both failed to confirm that they understood the detail of the Briefing.

- The COSS did not communicate to the Engineering Supervisor (ES) or Authorised Person (AP) that the work team would be erecting a mobile tower scaffold , nor was the use of a mobile scaffold tower mentioned in the 'white board briefing'.

Section of scaffold pole resting between the No 3 Up Conductor Rail and Down Charing Cross running rail.

- COSS's used on Thameslink to have competency formally assessed.
- Introduction of compliance checks at site level, when scaffolding is used and to confirm understanding of possession arrangements.
- Increased frequency of random D&A testing to deter substance abuse.
- Site Supervision to undergo competence checks related to tasks they supervise.
- Contractor to ensure adequate site presence of supervisors.
- ES/AP's briefing for multi-part possessions are to be clearly communicated to all COSS's and confirmation received that they have a full understanding of the safe work limits for each part of the possession.
- COSS's to stand-down work teams and re-brief any changed arrangements when moving between parts of possessions.
- Introduce process to ensure version control and legibility of SSOW packs.
