Shared Learning

The Thameslink Programme

Issue Number: TLP082

Title: Flashover During Tandem Lifting Operation

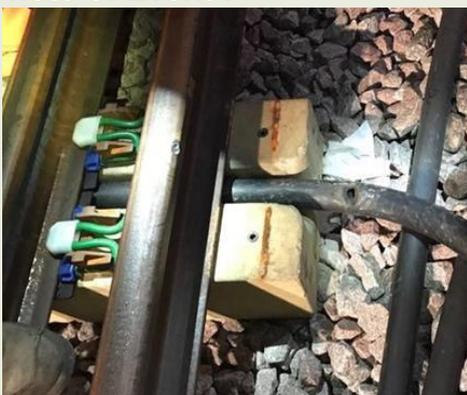
Photo of Event :

The loose rail which had been stored on the sleeper ends had vibrated onto the ballast and had compromised the sheathing of an energised traction cable sitting on the ballast.

Immediate Cause – Metallic object coming into contact with an energised conductor.

- The timely removal of redundant materials following completion of work.
- The sub-station DC circuit breaker had tripped several times over previous days, suggesting that there was a short circuit in the local area.
- As rail was stored on sleeper ends for a prolonged period, it appears that it vibrated off over a 52 hr possession due to vibration compounded by minimal ballast between the sleepers and the track not being bedded in.
- The Work Package Plan was written before new DC cables were energised and did not assess the risk associated with the DC or signal cables adequately.
- The Task Briefing Sheet and Lift Plan was generic and did not mention the use of a Road Rail Vehicle or specific details of the lifting arrangements.
- The removal of the rails had been planned on two prior occasions but due to delays and lack of planning for future works this had been curtailed.

- Review of the process around producing Lifting Plans.
- Implementation of enhanced audit checks for Task Briefing Sheet relevance/quality.
- Examine the protocol around sharing information between Network Rail and the project team on operational issues, such as electrical trips.
- Enhanced protection and controls around working in proximity to DC feeder cables, to be agreed briefed and implemented.
- Carry out first aid needs assessment to ascertain if the first aid provisions and training are suitable and sufficient for the work carried out.
