The Thameslink Programme

Issue Number: TLP083

Title: Cable Drum Spindle Fall into Public Area

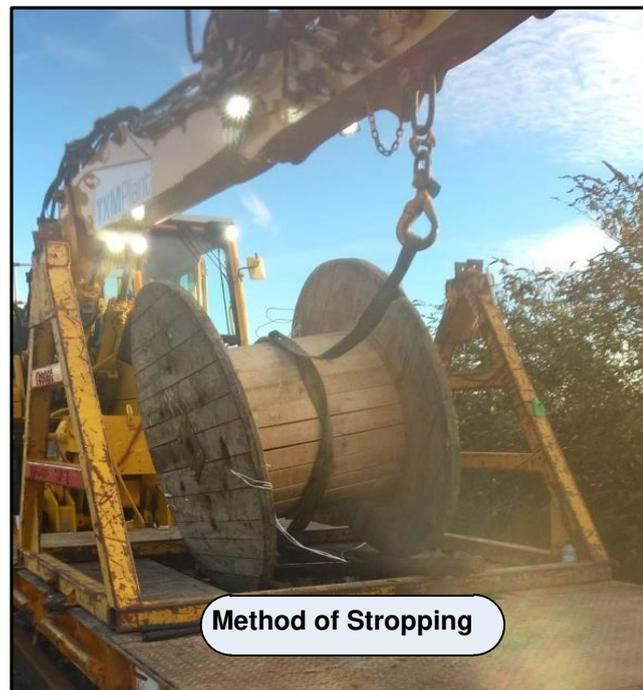
Method of Stropping

- The drum was incorrectly slung with a single Strop allowing it to tilt.
- Lack of competence/experience of the team in lifting cable drums.
- Cable drums had been stored on their sides on the trailer.

- Communication issued to the project/supply chain that lifting must be carried out in accordance with the Principal Contractor 'Lifting operations: Our Expectations' process.
- Going forward, diagrams/instructions to be included in cable drum Lift Plans, including stropping arrangements.
- Safety Bulletin issued – 'Lifting of cable drums on bridges and the correct procedure for lifting, including the prohibition of lifting on viaducts /under bridges without a detailed Risk Assessment'.
- Project instructed to place all cable drums into the correct storage position on their rims.
- Mandate and train supervisors in the use of Lift Plan assessment sheets and POWRA (point of work risk assessment).
- Re-training and assessment of the Crane controller involved in the incident, followed by a period of mentoring.

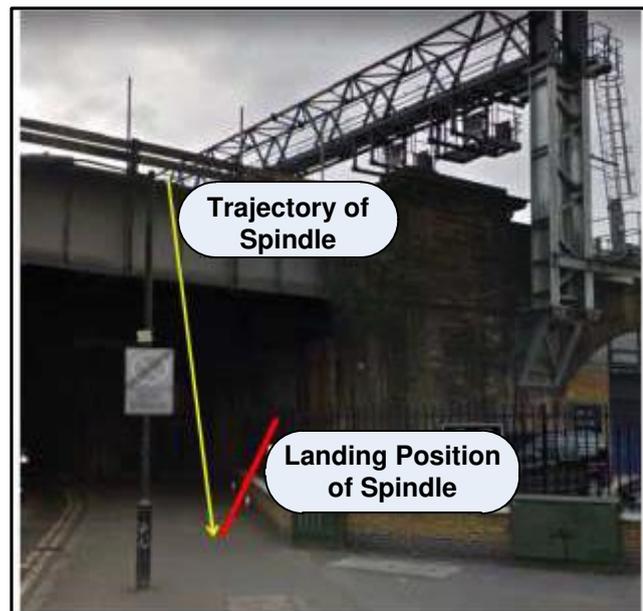
On 19th November 2017 at 13:00hrs, a track team was lifting an empty cable drum from an 'A' Frame mounted on a track trailer. During the lift, the cable drum spindle bar snagged on the 'A' frame. On further attempting to lift, the drum jerked and tilted causing the spindle bar to slide from the centre of the drum. The spindle bar fell through a gap in the parapet wall approximately 8m to the ground below, into a public area.

Trajectory of Spindle

Landing Position of Spindle
