# Shared Learning

## The Thameslink Programme

**Issue Number: TLP085**

**Title: Work Group Crossing Open Line**

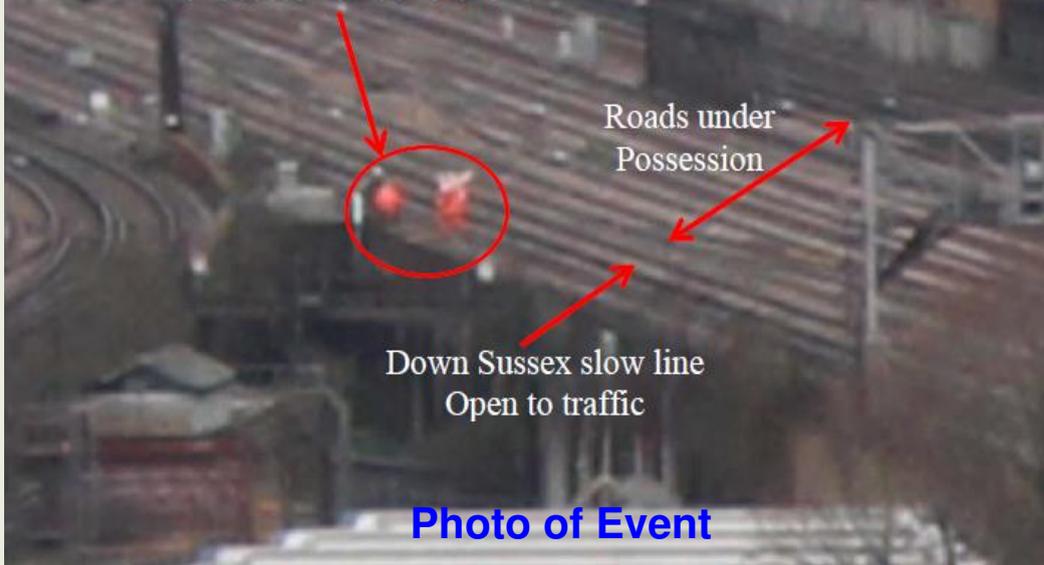
**Photo of Event**

While crossing the open lines one of the group noticed a nearby signal displaying a green aspect, at the same time one of the team is reported to have stood on an energized section of conductor rail and received a "tingling sensation". The COSS then realised this part of track was open to traffic and immediately led his team to a place of safety.

- Team crossed an open line.

Circled area approximate location of access Point and event

- Re-training, assessment and monitoring of the COSS involved.
- Implementation of non-working COSS's to remove any conflict between production and safety.
- All Task Briefing documents for work in possessions, with the potential to impact on open lines to be reviewed by the contractor's safety team.
- For future possession work, open lines to be sign posted at the most appropriate point on site as a visual reminder to teams.
