# Shared Learning

**The Thameslink Programme**

**Issue Number: TLP086 Title: Electrical Conduit Cut**

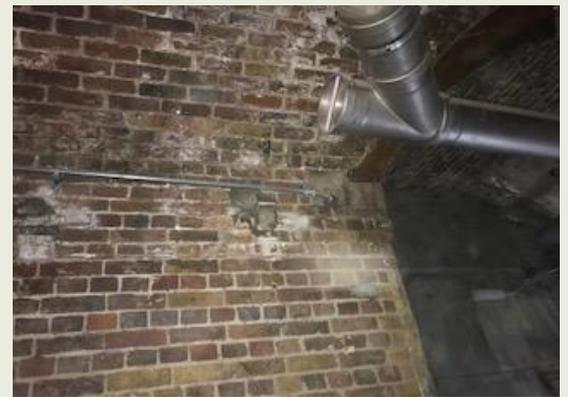
Photo of electrical feed that was cut

**Immediate** - The cutting of a live electrical conduit with a reciprocating saw.

**Error-proofing conditions:** An Isolation Certificate had been completed, however, this document was substandard and did not detail the location of the live electrical conduit as part of permanent work.

**Procedure:** The project has worked to an informal procedure where all cut ends are orange ended requiring all to work away from the cut end. The Demolition Supervisor believed the cables routed in cable containment above the false ceiling were isolated and proceeded with the removal of conduit however the cables had no orange end markings on them.

- The orange end process has been documented and communicated to all project persons to include services that are cut and removed from the work area and where removal is not feasible then isolated services be clearly "orange ended" at sufficient locations such that the operatives undertaking the works can clearly see the service. If any live services remain live in the area they must be clearly marked and protected on site.

- The revised isolation certificate now includes the requirement to undertake joint site visits to the area prior to any works. The permanent and temporary design drawings are to be reviewed and confirmed by the CRE for Fire Alarm, Electrical and Mechanical services representatives prior to work commencing.
