# Shared Learning

**The Thameslink Programme**

**Issue Number: TLP088**

**Title: Overturned Hoarding**

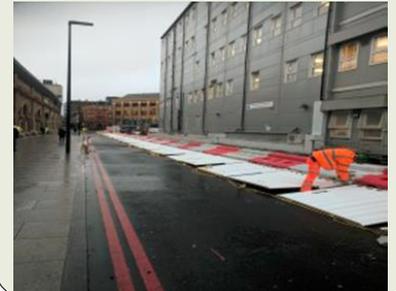
On the 27<sup>th</sup> December 2017 one of the hoarding lines measuring 68m in length and 2.25m high was blown over in high gusting winds. The hoarding was constructed using a proprietary plastic water-filled Safesite GB2 barrier system. The hoarding line ran along the pavement edge separating St Thomas St and the site offices. Although no one was in close proximity at the time of the incident, there was a risk to site personnel and members of the public.

**Immediate** - The immediate cause of the incident was a 'gust' of wind which exceeded the manufacturers maximum wind speed; this applied a force to the hoarding causing it to overturn.

- The Delivery team requested the GB2 system because it was easy for them to use. The TW Design team decided the only way that they could allow it to be used was to specify that the system was not suitable in high winds; solid panels must therefore be removed prior to the expected wind loadings. On the morning of the incident, panels had remained in situ and had not been removed.

- TWs Designers will only design temporary works where the design meets the design brief and is suitable for the foreseeable loading conditions. Residual risks being noted on drawings and incorporated into Permit to Load (PtL).

- An Inspection & Test Plan (ITP) will be incorporated into the Permit to Load which supports the assurance and checking regime, specifying what needs to be checked and when.

- Records of inspection and checking are to be maintained by the relevant TWS / TWC on the Permits to Load. An audit / monitoring regime of the PtL process will be developed utilising SharePoint and be managed by the TWC.

- The project will distribute a daily weather forecast, to relevant persons, highlighting potential inclement weather and associated Project Risks. Where necessary an individual within the TW team i.e. the TWS, must maintain a watching brief on weather conditions which may affect temporary works associated with their Permit to Loads.
