Lessons Learnt from a Significant Event

Issue Number: TLP001

Title: Bermondsey Dive Under Project, Severe Burns

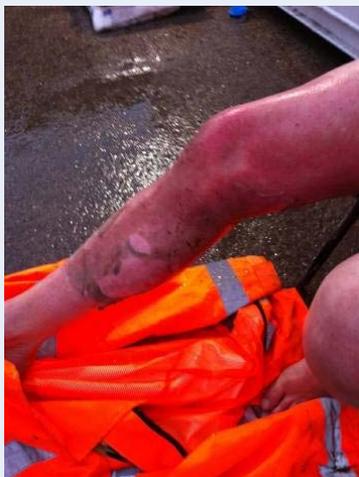
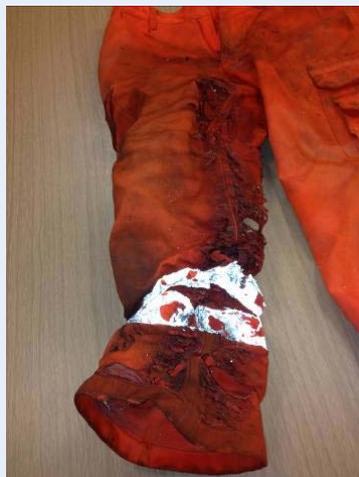
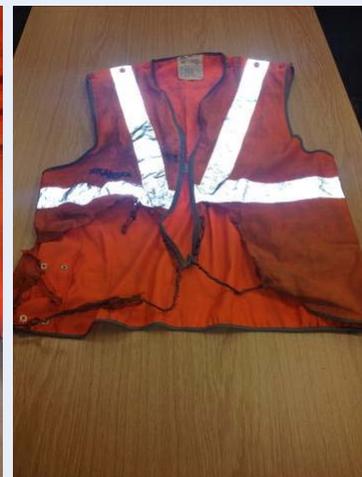
Picture(s)

Photographs show the burn injury to the operative's leg as well as the condition of the PPE after the accident

An operative sustained serious burns to his leg and hand which required skin grafts.

The operative had been horizontally cutting off 32mm vertical reinforcement bars that were protruding from recently constructed piles using a petrol driven Stihl saw.

As the operative was cutting through one of the bars, he was unaware that he was being doused with fuel that was escaping from the petrol filler cap.

Sparks generated from the cutting, ignited the petrol, which in turn set fire to his hi-visibility trousers and vest.

* The IP was wearing standard issue trousers which are nylon. The Stihl saw manual recommends when cutting steel that flame retardant materials should be worn. The fact that an accelerant was involved may not have prevented the injury however this highlights the need to review user manuals for specific instructions.

- No task briefing had been provided for the task and a risk assessment was not in place
- No user manuals for Stihl Saws had been provided by the plant hire company
- Whilst training demonstrates use of these tools in a vertical position to ensure 90 degree cutting angle it appears to be common practice to use these tools to cut back rebar and other activities with the blade in the horizontal position
- Abrasive wheel training relied upon for the competence of the individual did not cover the use of this type of saw therefore provision of manuals and inclusion of controls in the risk assessment / task briefings was crucial

Consideration for alternative methods of cutting such as hydraulic cutting for the removal of vertically protruding reinforcement bars from piles

Pre-use checks are required to be undertaken on machinery / tools in order to establish they are fit for purpose

Plant / equipment suppliers should provide manuals for equipment provided

Manuals should be used to inform the risk assessment / task briefing

PPE selected should be appropriate for the task

No works are permitted without a task briefing being undertaken
