## Issue Number: TLP017

**Title:** London Bridge – Combisafe Bracket Fell from Height (27<sup>th</sup> January 2014)

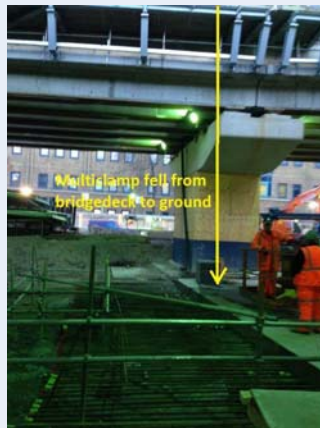
Shows platform 14 above with service yard below.

Yellow arrow indicates where clamp fell from and to.

- Co-ordination of activities on site should be understood by all parties including Sub Contractors and Engineers.
- The management of exclusion zones should be clear for all works.
- Exclusion zones should utilise robust barriers with signage that are not easily moved.
- Specialised training / briefing should be given to operatives who use specific equipment ideally by suppliers / manufacturers e.g. Combisafe scaffold system

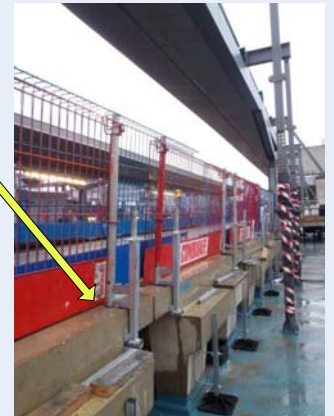
Platform 15 illustration of combisafe system with standard and clamp attached to concrete slab.

- There are a number of underlying facts that contributed to the event: -
- Poor co-ordination of the activities led to the situation of putting two sub contractor operatives at risk from the falling clamp.
- Failure of scaffolders to either put in place or confirm that others had put in place an exclusion zone or other arrangements, to protect persons from falling objects, before they proceeded with the work. Assumptions had been made that there was an exclusion zone below for other works.
- The methodology used to dismantle and install the Combisafe equipment created a condition where the scaffolder was unable to prevent the clamp from falling.
