Issue Number: TLP 025

Title: London Bridge – S&T Cable Cut (25th October 2014)

Overview of Event:

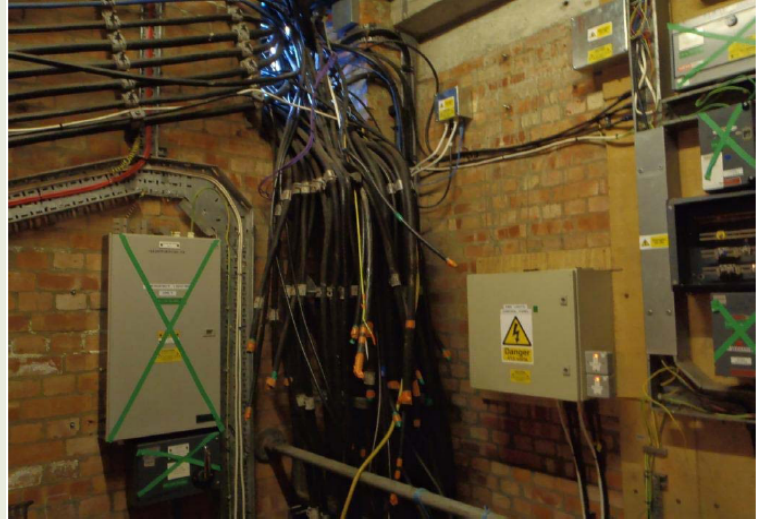
Cables were being removed from a service riser on platform 6 of London Bridge utilising a reciprocating saw. During the activity the saw blade came into contact with one of the live S&T cables cutting through the outer and inner insulation damaging the internal cable cores. Work was stopped immediately; Network Rail S&T were contacted to examine the cable. The damage caused a fault but did not cause any delays to trains. A repair was undertaken.

Inside switch room platform 6 showing mix of orange ended redundant cables and cables still in use

- Failure to adhere to the documented safe system of work – as it had identified hand cutting where live cables had been identified.
- The task briefing didn't take into account accessibility of the cables and offer alternative methods other than referring to hand cutting - the specified list of tools for the task in the TBS stated reciprocating saw & hand tools.
- The chosen method was inherently unsafe around live cables - the close proximity of the live and redundant cables made either of the suggested removal methods in the TBS unsuitable.

- The use of reciprocating saws to be prohibited unless there are no live services within the area.
- A hold point has been incorporated within the TBS system to review the safest method of removal for all future cable removal works carried out in close proximity to known live services.

- Alternative cutting methods e.g. ratchet cutters are being explored. Where access is limited the removal methods will be reviewed to identify the safest way (potentially using shields to protect services).
