Shared Learning

COSTAIN
The Thameslink Programme

Issue Number: TLP033
Title: London Bridge Hoarding Blew onto Track (5th May 2015)

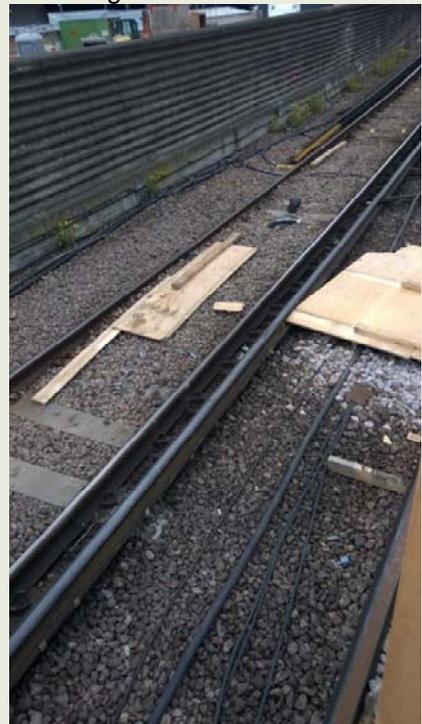
A train struck a section of plyboard hoarding after it became detached in high winds and fouled the running line on the Charing Cross 'Up Passenger Loop' at London Bridge. Hoarding works required removal and modification of sections of hoarding as works progressed on the project. The hoarding had a design for its final installation, however the connection detail where the modified hoarding abutted the existing hoarding was not detailed / covered in the design.

High winds up to 90kmh imposed a load on an exposed and unsecured section of the hoarding causing it to become detached and fall onto the track of the operating railway.

- **Design** oversight resulted in a lack of detail for the corner connection . The 'new' hoarding plan was to terminate at an interim position with the final hoarding position being at a later date.

Hoarding on the tracks

- Designs to include hoarding to hoarding connection detail including layout plans. Layout plans to be issued to NR under Form 3 acceptance and included in the temporary works plan.
- Procedures to be reviewed / audited in connection with permit to load requirements / responsibilities.
- Training / briefing of the team in respect of the permits to load procedure and responsibilities.
- A pre-start assessment of the working environment will be undertaken to make sure the WPP / TBS is adequate.
- Planning / organisation – checklists of responsible persons to carry out key tasks to be incorporated into the planning process including the requirement for completion of the form 5 as required by Network rail.
