## Lessons Learnt – Builders Work Holes

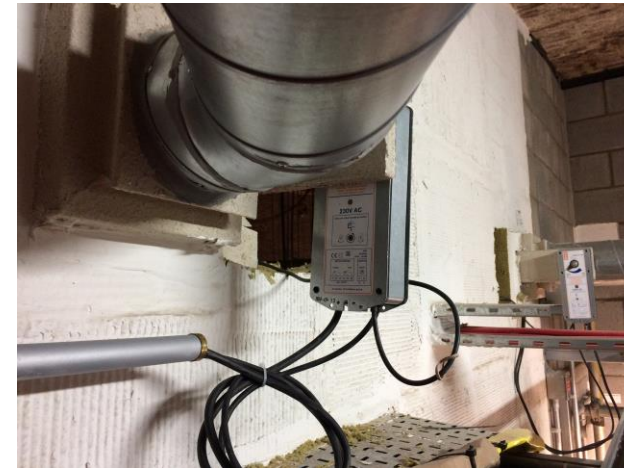
Builders work holes were provided much larger than required for the supposedly co-ordinated services that are designed to be using the route. This results in excessive amounts of fire-stopping being used on the project – intumescent coated fire batt having been extensively used on this project.

Example of excessive Builders Work Holes.

Provide the correctly sized builders work holes as per the initial design stage – rather than the “bigger is better” attitude. Continue this into the construction phase. Where thinner products are used for fire stopping, ensure co-ordination exists between the service installers and the fire stoppers. E.g. Ensure the services and fire stopping is aligned on the same side of the wall line – or install for the full thickness of the wall.

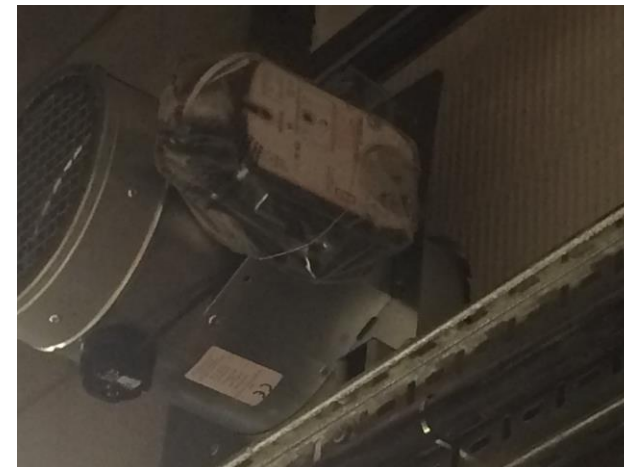
Additionally, the thickness of the fire-stopping product is less than the wall into which it is installed (e.g. 140mm block wall infilled with 50mm fire batt). This becomes another issue for fire damper installations where dampers are installed flush to either side of the wall in advance of the fire stopping. The fire batt is then installed either level with one of the wall faces, or within the centre of the wall line itself. All of which can leave the damper sitting unprotected and away from the wall.

Example of fire batt installed inside the wall line.
