Case Study: Signage

London Bridge Station Redevelopment

Recommendations for future projects to improve the planning, management and delivery of temporary and permanent signage

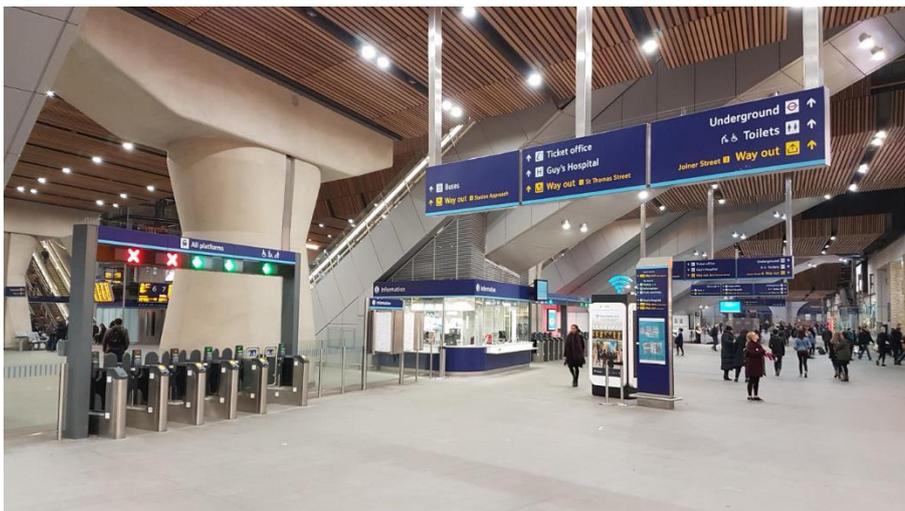
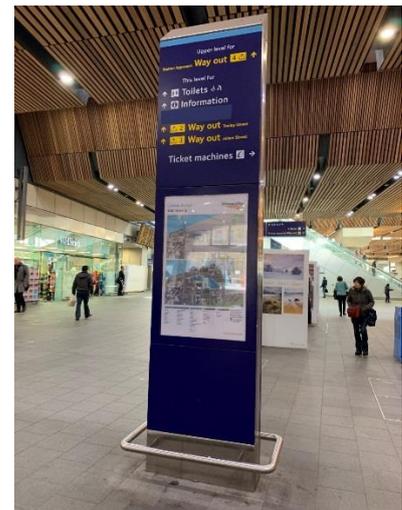
These photos show the range of permanent signage produced by Merson for the gate-lines, the ticket office, the ceiling-hanging wayfinding for passengers.

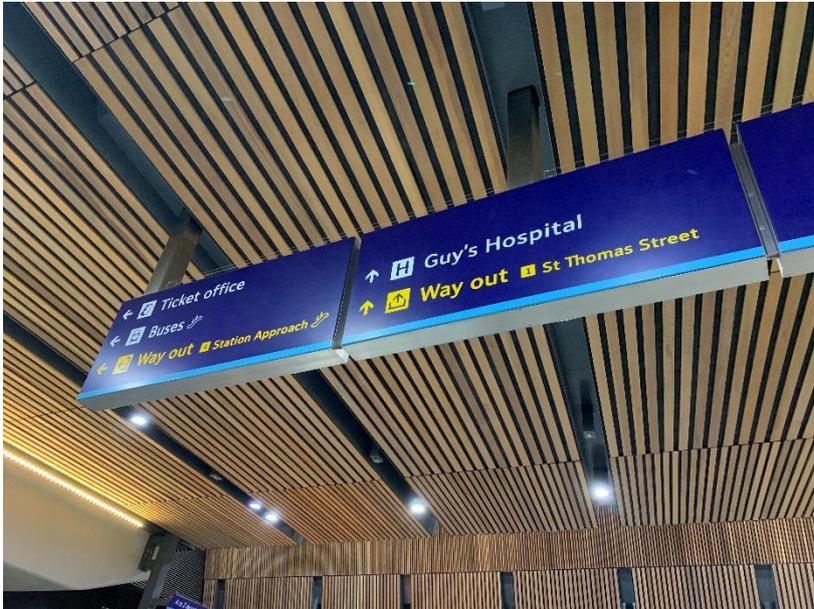
A typical hanging sign that needs to have wind-loading in its design specification.

Early involvement of key contractors with Merson Group would have allowed earlier resolution of any problems they saw arising based on previous experience. For example, if there was a sign planned for an open concourse area, the weight of that sign may need to be adapted to consider wind loading. Site visits, discussions with partners and other suppliers at the very early planning stages may have helped predict these challenges earlier such as the A-line, which had no fixing points for signage.

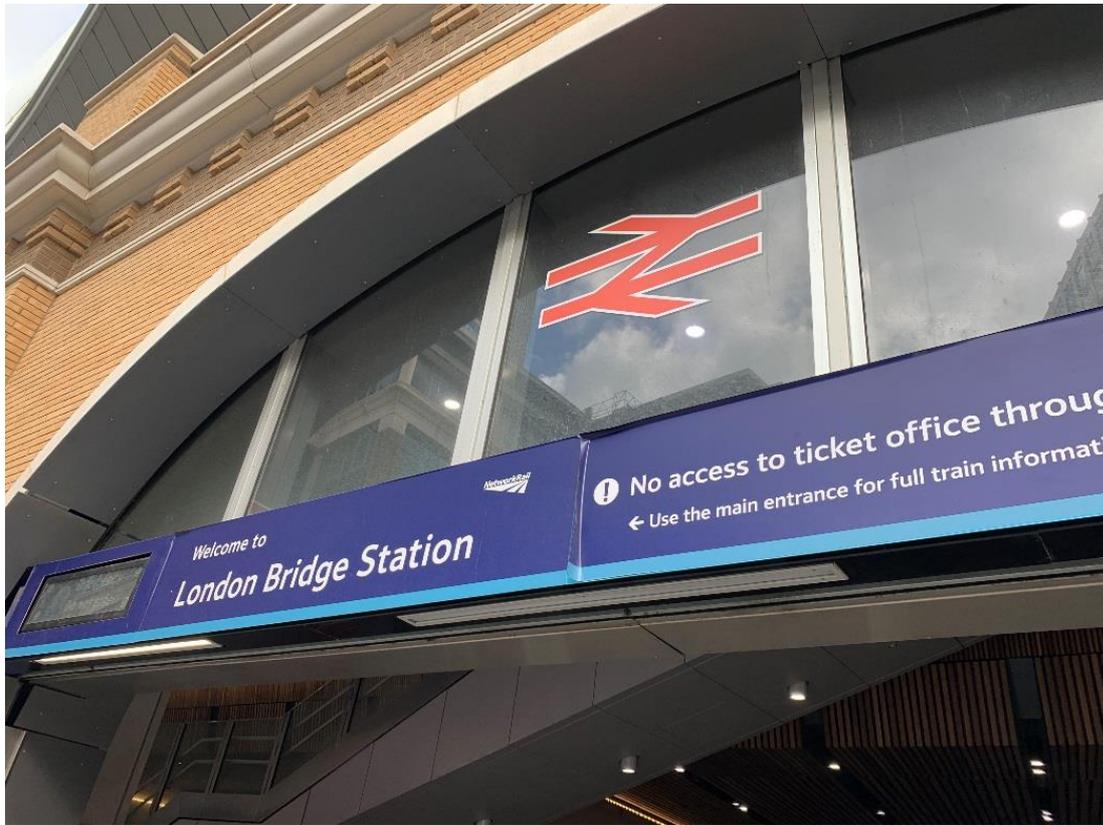
The above sign is a temporary example that looked and felt permanent during the construction stage but was replaced later.

Temporary signage is very valuable while awaiting installation of the more robust permanent signage. Using temporary signs means that ongoing construction works can happen around signs without worrying so much about damage.

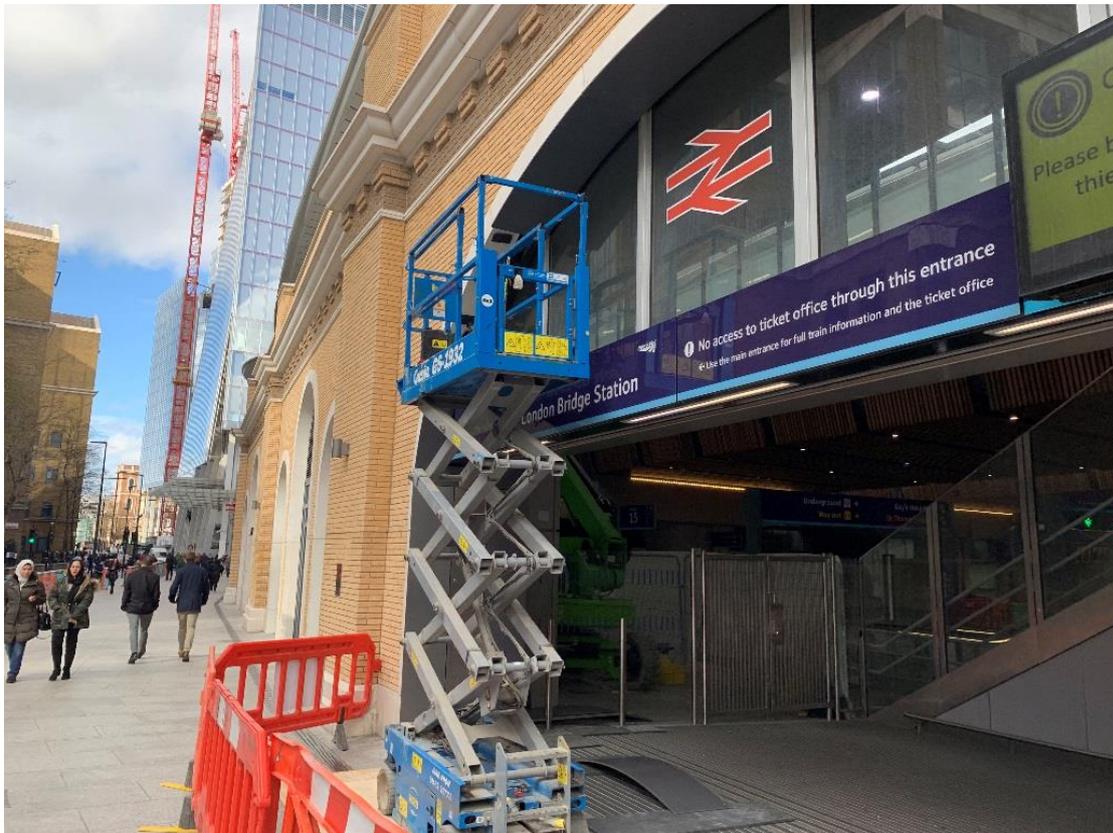
A permanent sign installation required careful passenger management.

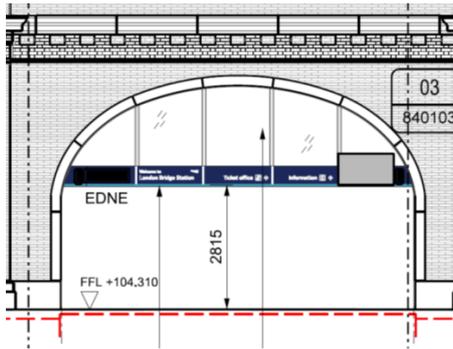
St. Thomas and Tooley Street Entrance Fascias

1. Design intent did not work.
2. Access request for maintenance.
3. Fascia height was too shallow.
4. Artwork alterations.
5. 8 no. interfaces.
6. STQs.
7. Merson developed solution.
8. SDRs (More drawings).
9. Mock-up built.
10. SQRs (Glass and mock-up).
11. More drawings.
12. Installation now on nights.
13. Commercials.
14. Paperwork.

As shown above, a permanent sign installation that needed changes often had a large administrative burden.

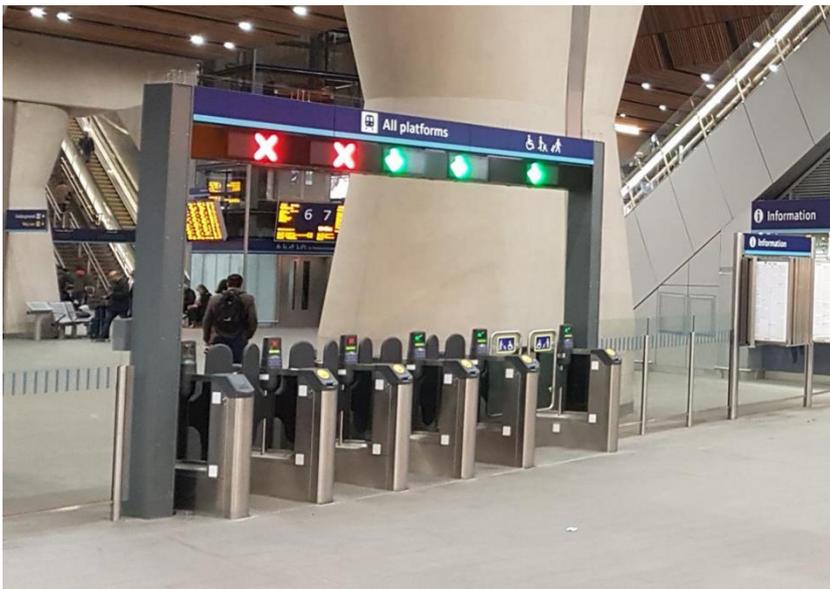
These gate-line gantries could have been assembled offsite

The overhead signs on the gate-lines could have been installed offsite without disruption to passengers or station operations. The entire units could have been manufactured outside the station and installed in a single operation.
