Case Study: Structural Steel Fabrication

Farringdon Station Redevelopment

Recommendations for future projects to improve the structural steel fabrication and installation processes

Structural steel fabrication and installation on the Thameslink Programme

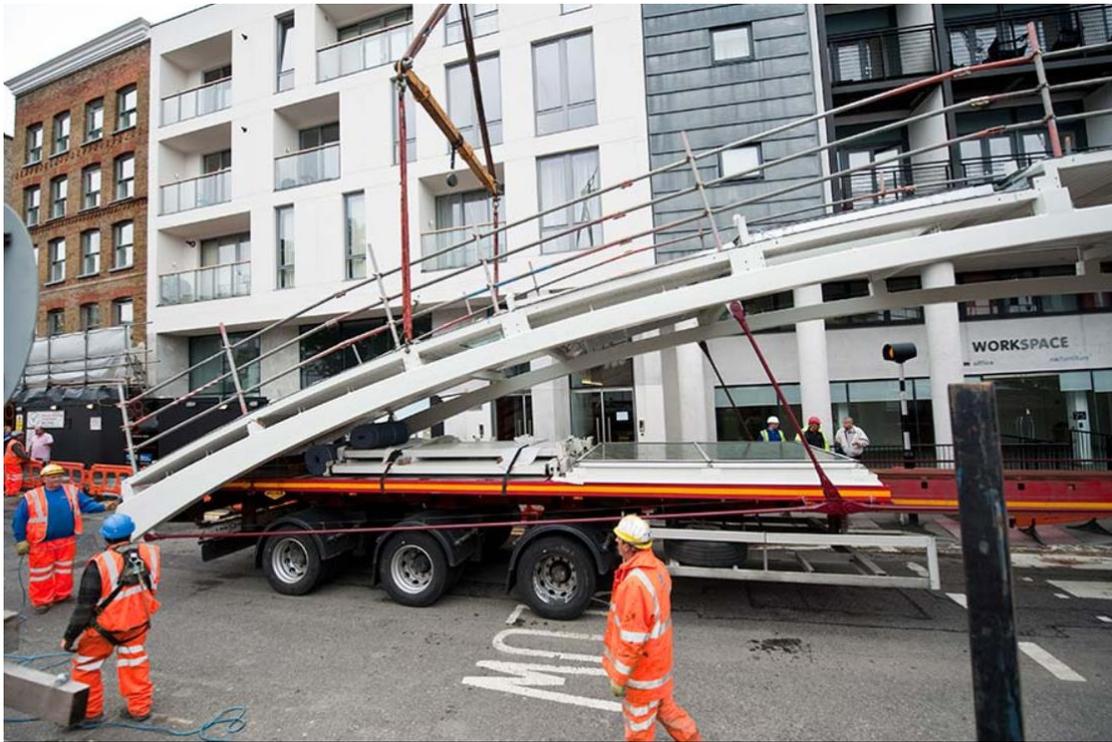
The new roof was too large to try out the assembly in advance offsite. The huge curved trusses were manufactured in pairs but once on site, they could often only be installed one at a time per night during track possessions, so there was no room for error. As each curved truss weighed from 12 to 18 tonnes, it was paired up offsite as a pre-installation trial to ensure it would fit once on site.

The new train shed roof was the biggest challenge for Bourne Group at Farringdon. The existing arched Victorian roof was to be extended and so the new section had to be built over the live railway lines. These lines would need to be kept open during the construction period.

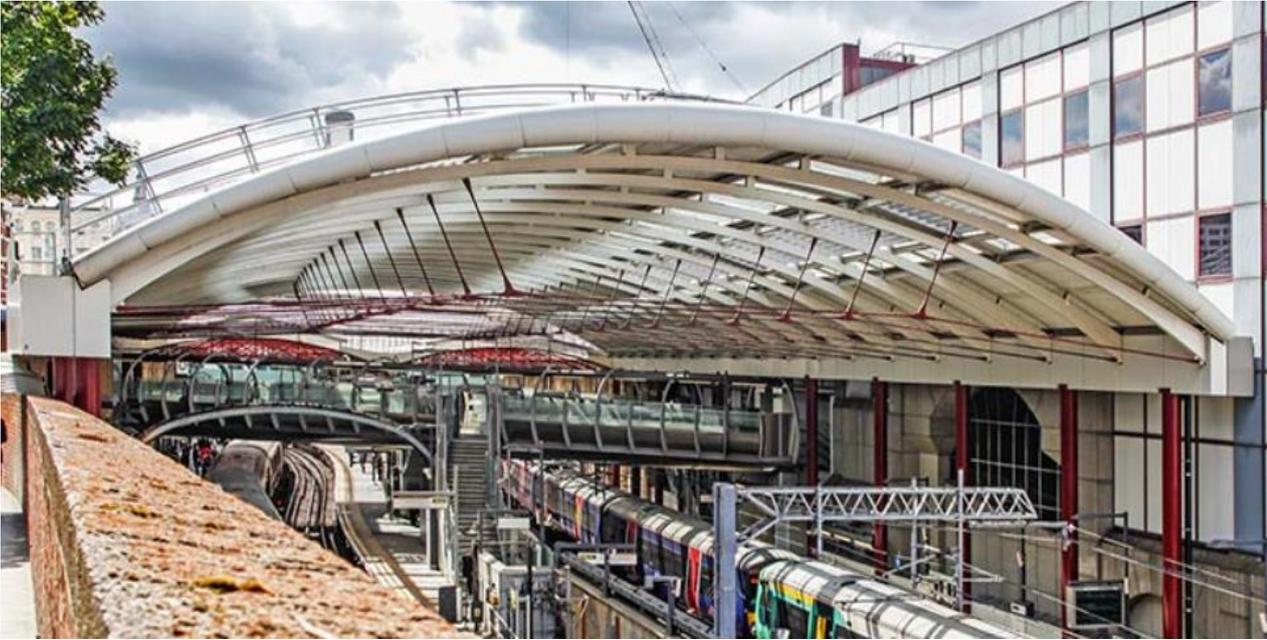
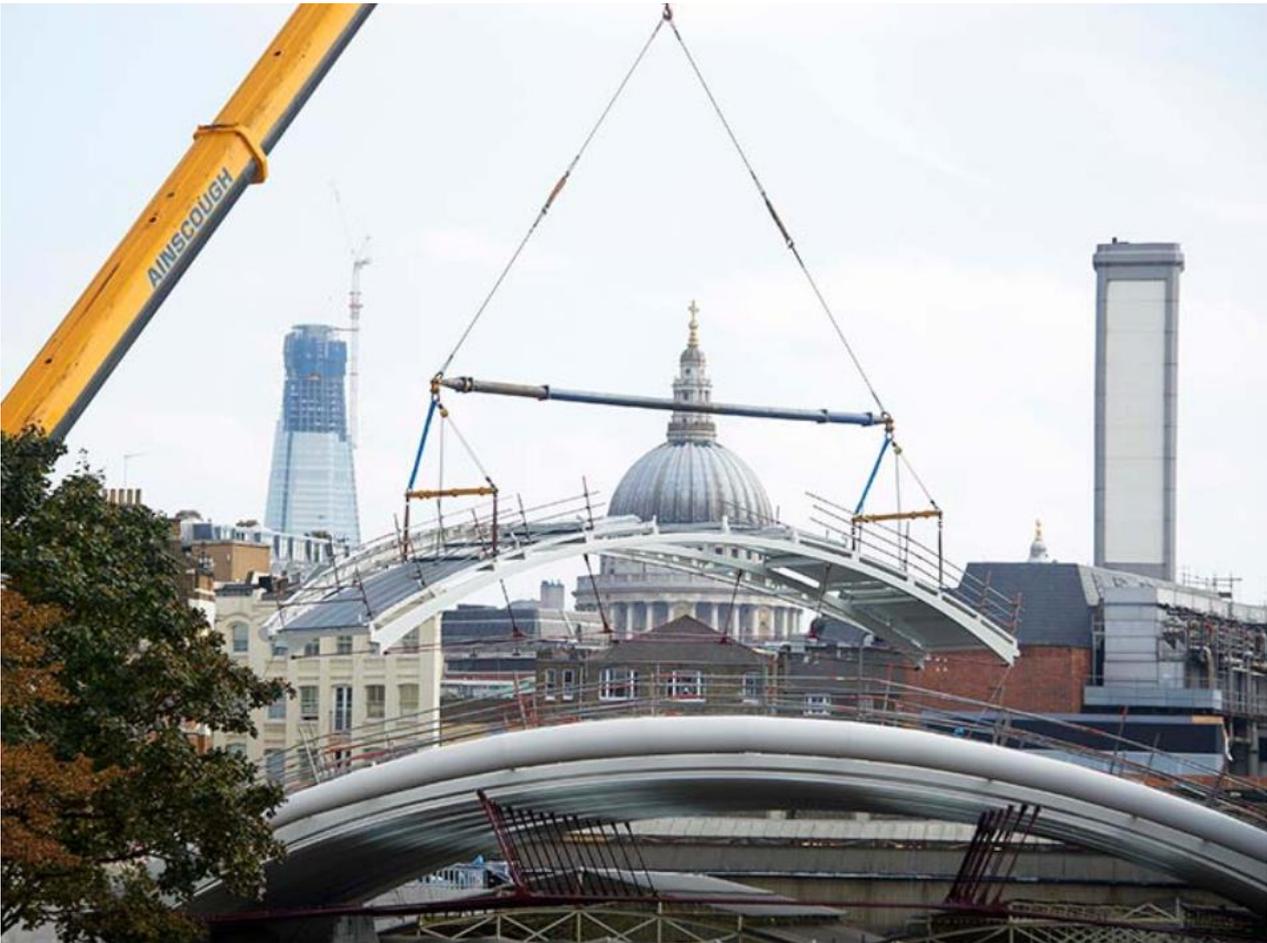
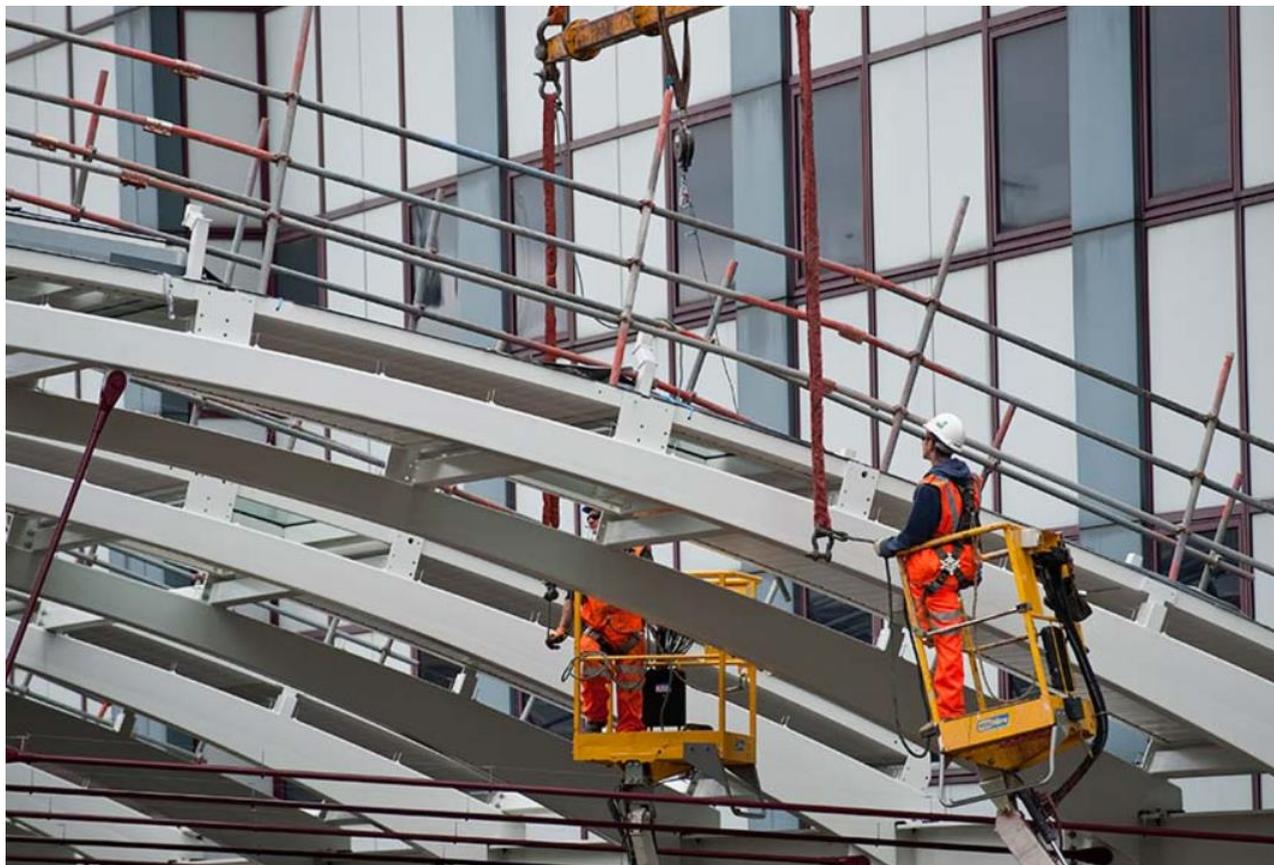
The key for the success of the installation was the trial assembly off-site. At the factory, there was a moving bed in the yard which allowed the trial assembly. The company first manufactured one big curved truss and placed it in the moving bed. This was followed by the next one to ensure they would fit together.

The first one was then moved away to be painted by a specialist painter to Network Rail's specification. This also involved complex transport logistics before it was brought back to be cladded. By that time, the third section was manufactured and ready to be trial-fitted with the second one. This process was iterated with each new piece passing through the pre-assembly process which gave the team confidence that every piece would fit once they reached site.

The station's space limitations also meant parts of the roof had to be prefabricated in sections that were cladded, glazed and assembled off-site. This required very clear and informative communication between the various suppliers before the manufacturing process began.
