Issued By: Thameslink Programme, HSEA Team, James Forbes House, 27 Great Suffolk Street, London SE1 0NS

Issue Number: TLP 028

Title: London Bridge – Angle Grinder Foot Injury (5th December 2014)

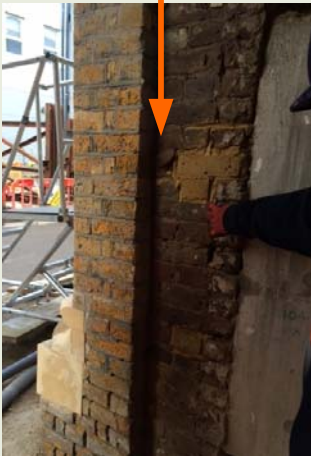
As part of the conservation and restoration of the Grade 2 listed wall on St Thomas Street façade an operative (restorer) was cutting a horizontal joint in the brickwork with a 5” angle grinder. Whilst doing so the grinder jumped / snagged out of the restorers hand and landed on his foot. The grinding disc cut through the boot and into the operatives foot. The injured party damaged a tendon in his foot and required surgery.

Area where wall was being cut

- The sub-contractor involved is now utilising anti-kick back type grinders
- The site teams have been briefed on the accident
- Discussion of the accident will take place at the the next sub-contractors meeting including the use of anti-kick type equipment
- Future pre-start meetings with sub-contractors will include types of equipment required
- Awareness training will be given to the site team on how to recognise the anti-kick back type equipment
- Safety inspections will include checking equipment being used on site
- Costain and Network Rail (Thameslink) will be developing a common standard for equipment of this type and issuing in due course

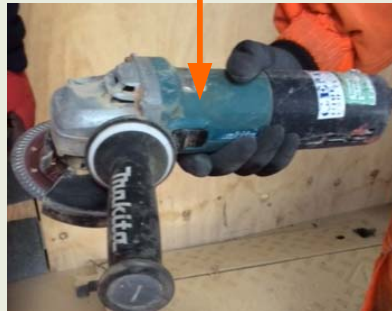
Grinder On / Off Switch

- Where equipment is supplied by the Principal Contractor they are normally fitted with anti-kick back clutch devices, however this is not mandated on equipment used by sub-contractors
- The grinder used was not fitted with any mechanical / electrical protection to automatically stop the blade when snagging occurred (anti-kick back)
- The task briefing could have been more descriptive with regards the risks

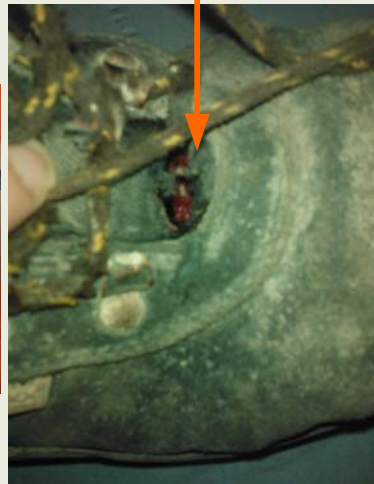
Cut to IP’s Boot

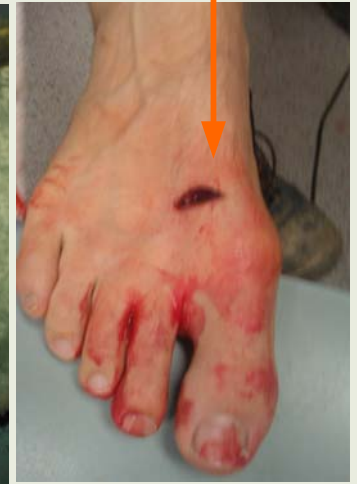
Injury to Foot
