Shared Learning

The Thameslink Programme

Issue Date: 21st Dec 2015 - For further info contact sharon.fink@networkrail.co.uk
Issue Number: TLP048 Title: Bomag Roller Overturn

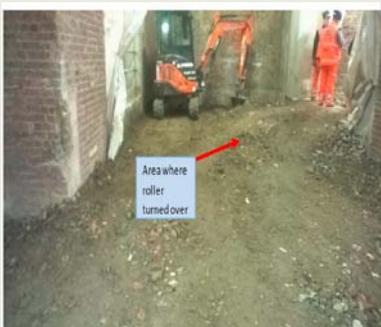
Photo of Event :

A Bomag 80 roller compactor was operating on the construction site at London Bridge in one of the arches rolling crushed stone which had previously been graded by the 3t excavator. As the operator reversed the roller he turned the steering wheel to reposition the roller back on to uneven ground at the end of a ramp which caused the roller to turn over.

The operator was not injured. He was wearing his safety belt which prevented him from falling out of the machine. The rollover protection system (ROPS) was in place and remained intact. There was some minor damaged to the roller.

Immediate - The immediate cause for the overturn was due to the operator reversing the Bomag 80 up onto the ramp with a gradient exceeding the Bomag 80 specification & turning the steering wheel to reposition the roller with the back roller sinking into soft ground which then caused the roller to offset its centre of gravity resulted in the rollover.

The principal cause of the event was that the wrong piece of equipment had been selected for the task. The compactor was operated in an area that contained a ramp with a gradient of 29.7 degrees which exceeded the manufacturer's operating instructions and therefore inadequate to ensure the safe operation of the compactor. This is considered an area with a significant hazard of rollover. There are safer alternatives where operators are not put at risk because they are not riding the equipment. Other findings included :

- Positive communications about wearing seat belts and having the roll over protection in place was shared as it prevented injury in this event.
- Ride on rollers have been replaced for specific works with remote controlled plant.
- The risk assessment for the selection of plant has been reviewed by the engineering team.
- Supervisors have been advised that all access ramps are to be constructed to a maximum of 20% (1 in 5) for a typical 1-5t dumper and that all access ramps to be compacted (8 passes per 100mm layers)
- Supervisors have been advised that where the TBS states an item of plant / equipment to be used and they need to utilise a different type then they must carry out a point of work risk assessment and seek advice if required.
